AlCl_3 -treatment of eutrophic Lake Littoistenjärvi:

Background and interim results

Heikkilä J. & Vepsäläinen M.

SYKE SEDIMENTTISEMINAARI -Lake restoration using aluminium salts: recent advances, results, and potential hurdles, Helsinki, 5.6.2017

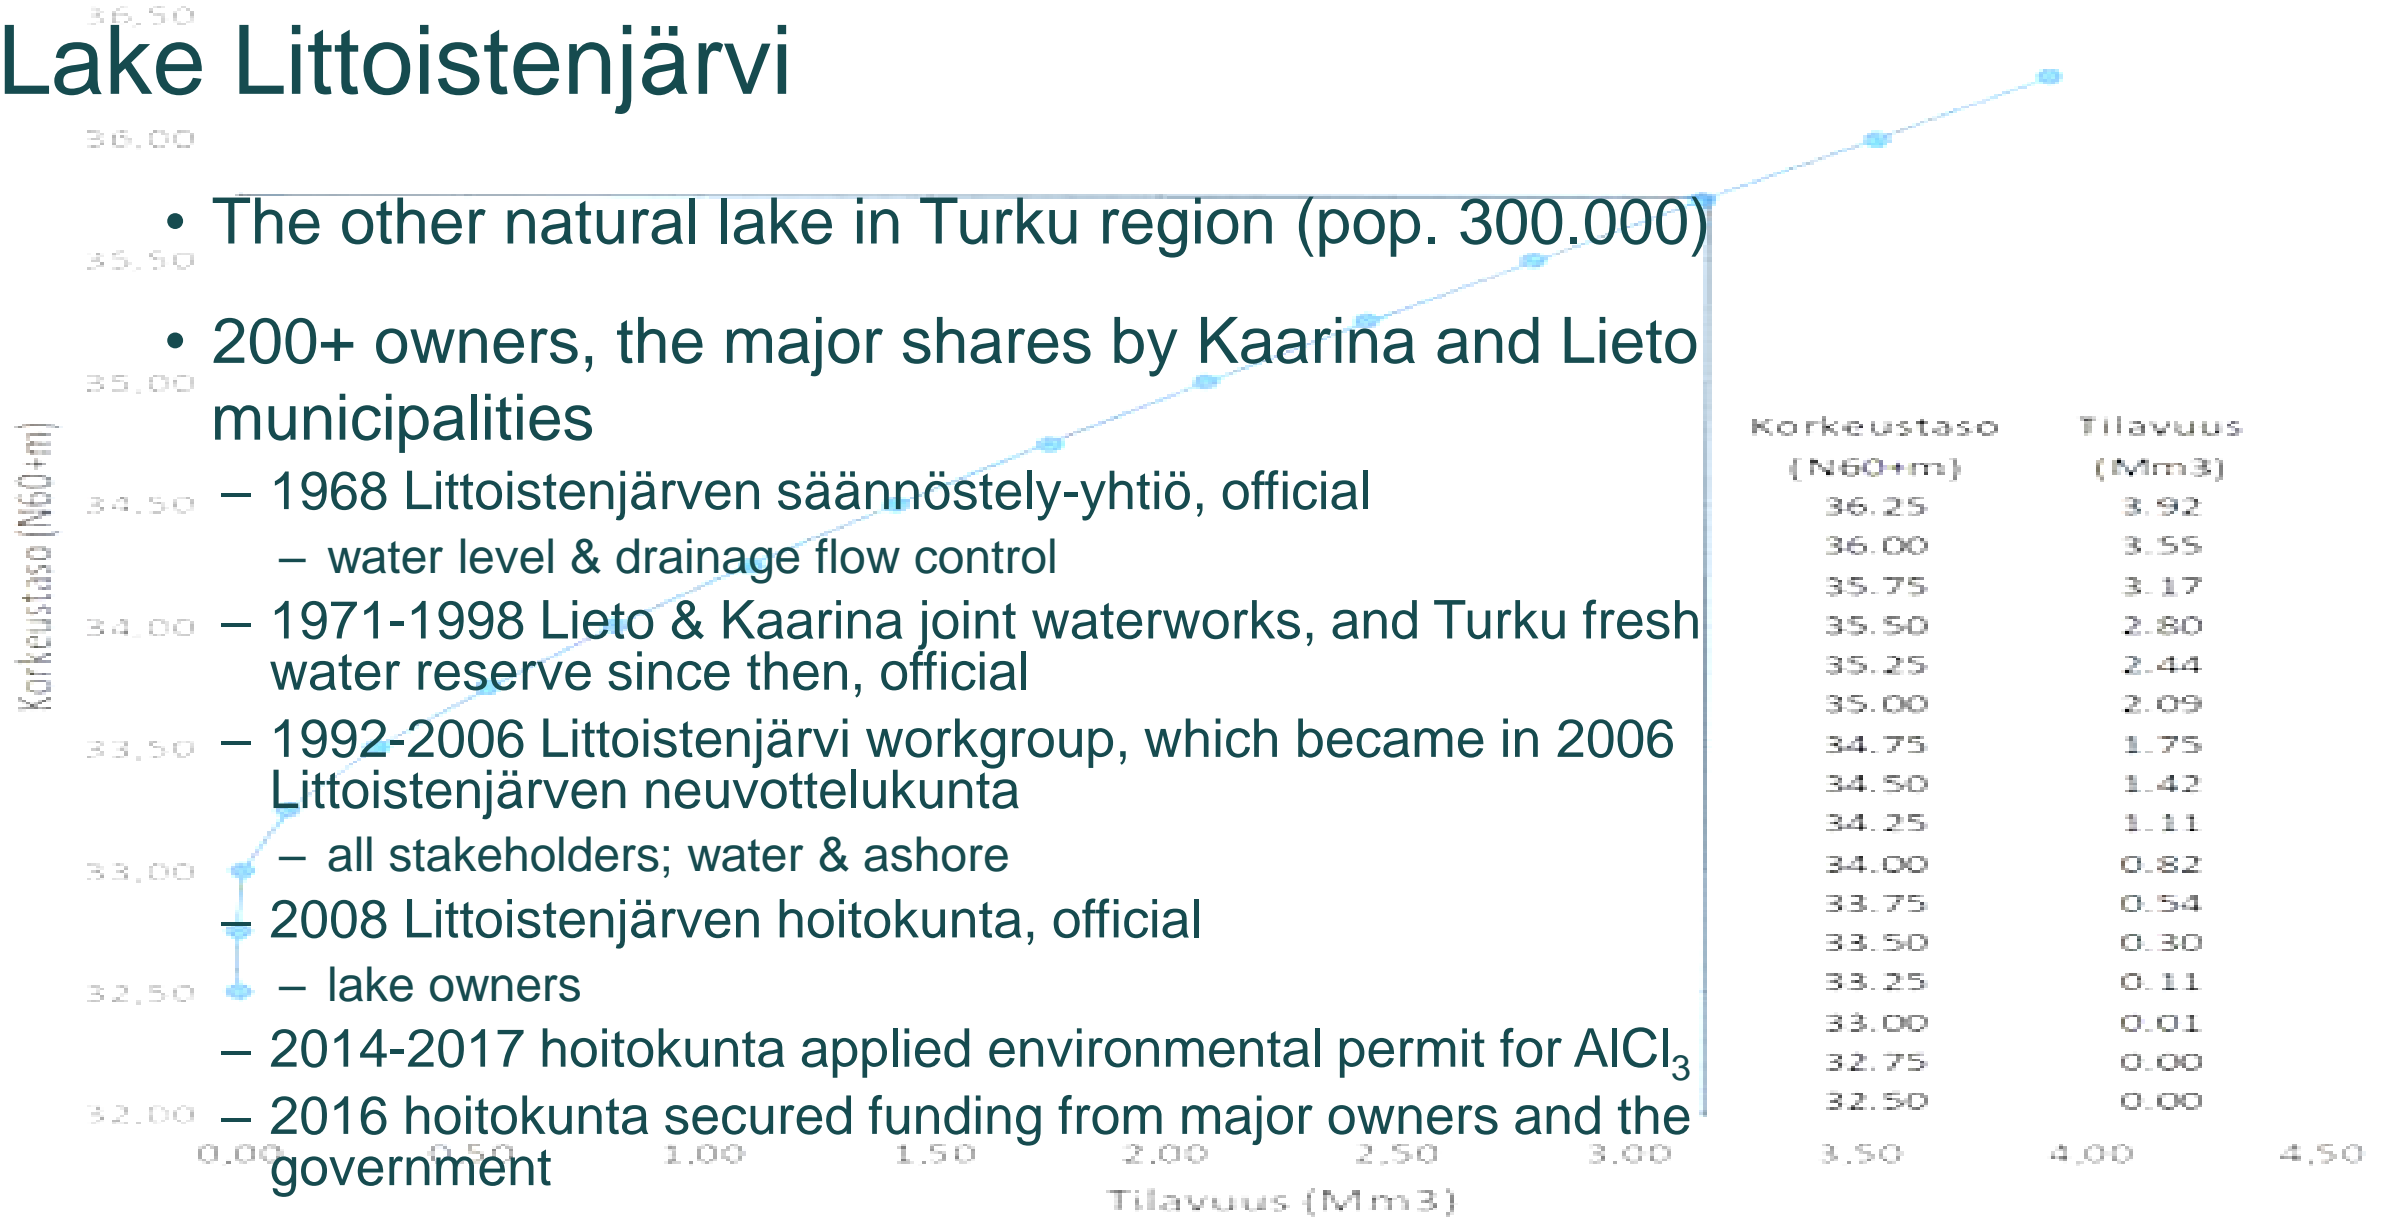
Lake Littoistenjärvi

- The other natural lake in Turku region (pop. 300.000)
- 200+ owners, the major shares by Kaarina and Lieto municipalities
 - 1968 Littoistenjärven säännöstely-yhtiö, official
 - water level & drainage flow control
 - 1971-1998 Lieto & Kaarina joint waterworks, and Turku fresh water reserve since then, official
 - 1992-2006 Littoistenjärvi workgroup, which became in 2006 Littoistenjärven neuvottelukunta
 - all stakeholders; water & ashore
 - 2008 Littoistenjärven hoitokunta, official
 - lake owners
 - 2014-2017 hoitokunta applied environmental permit for AlCl₃
 - 2016 hoitokunta secured funding from major owners and the government

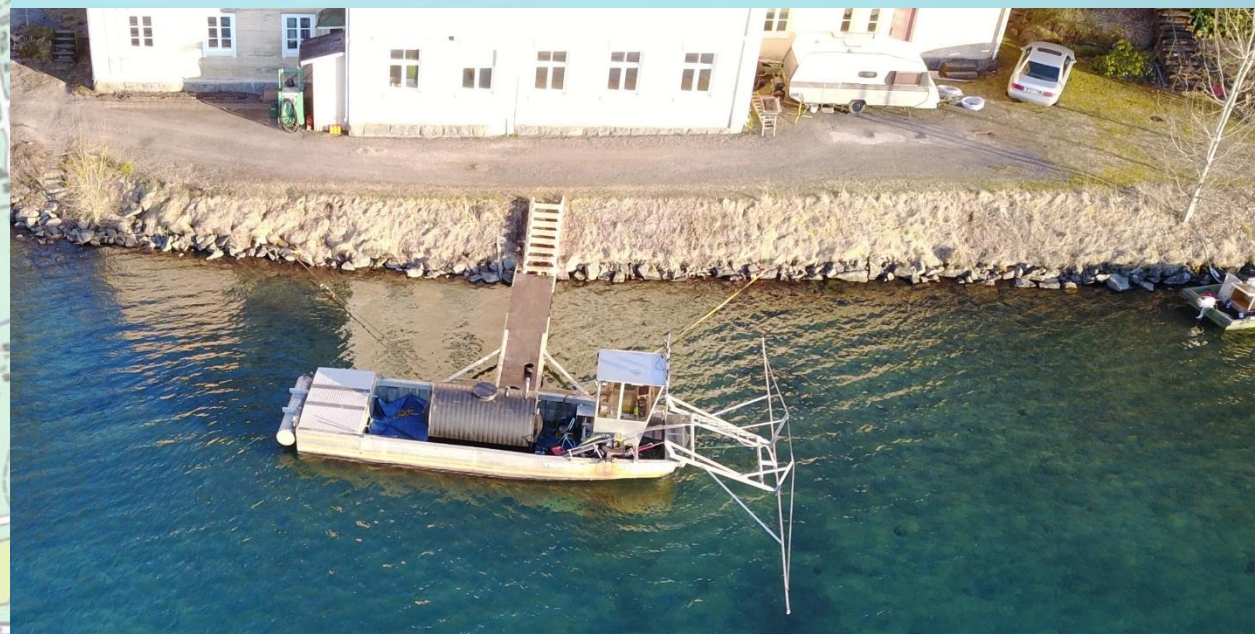
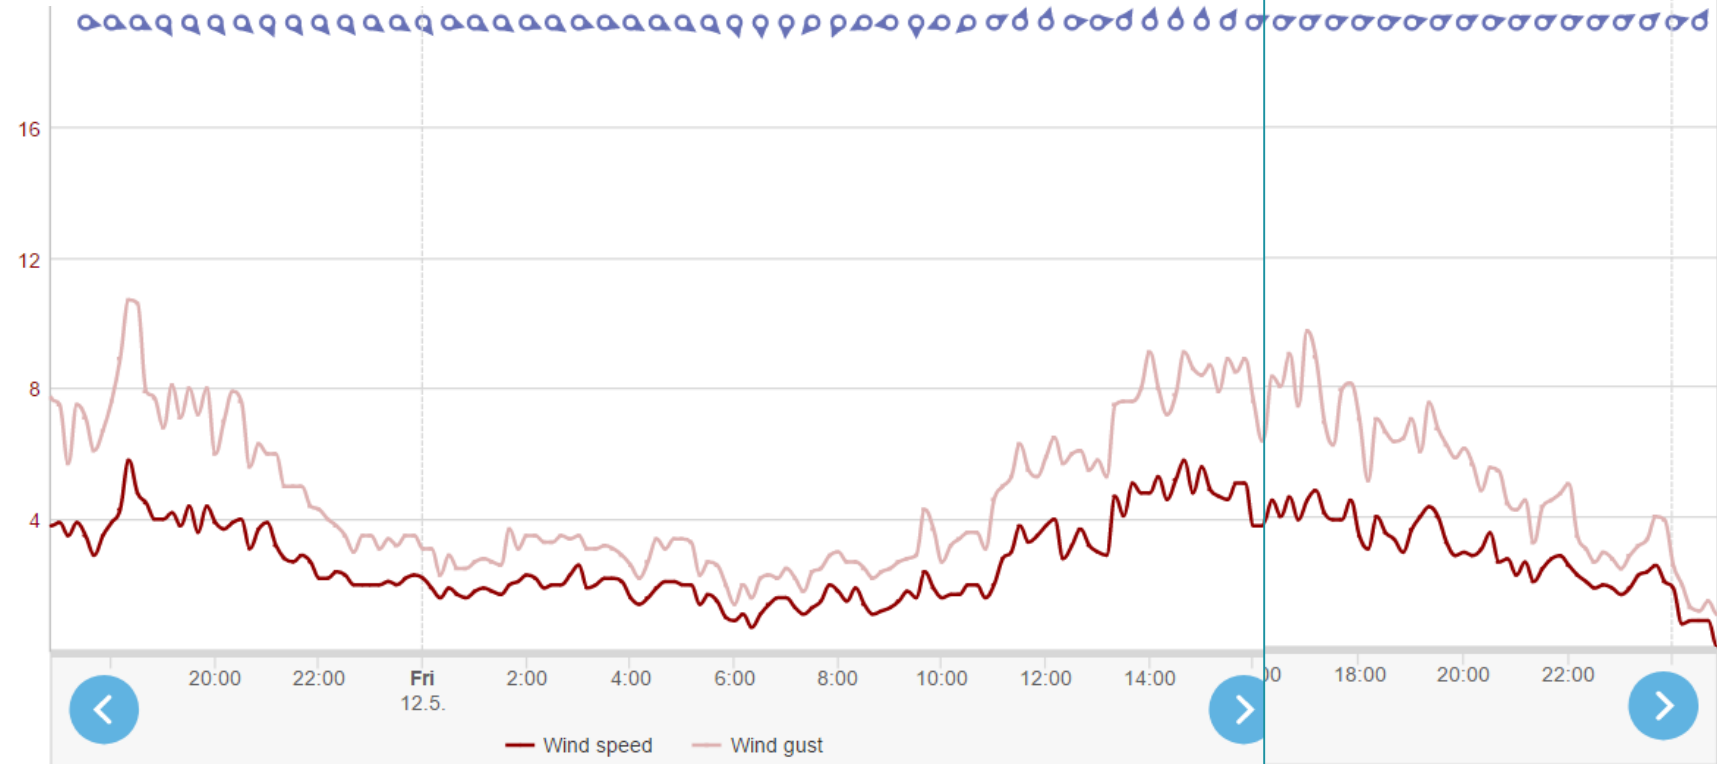
Weather Artukainen during treatment

1010-1017 hPa

-3,0...+10 °C

Varying winds 0...10 m/s

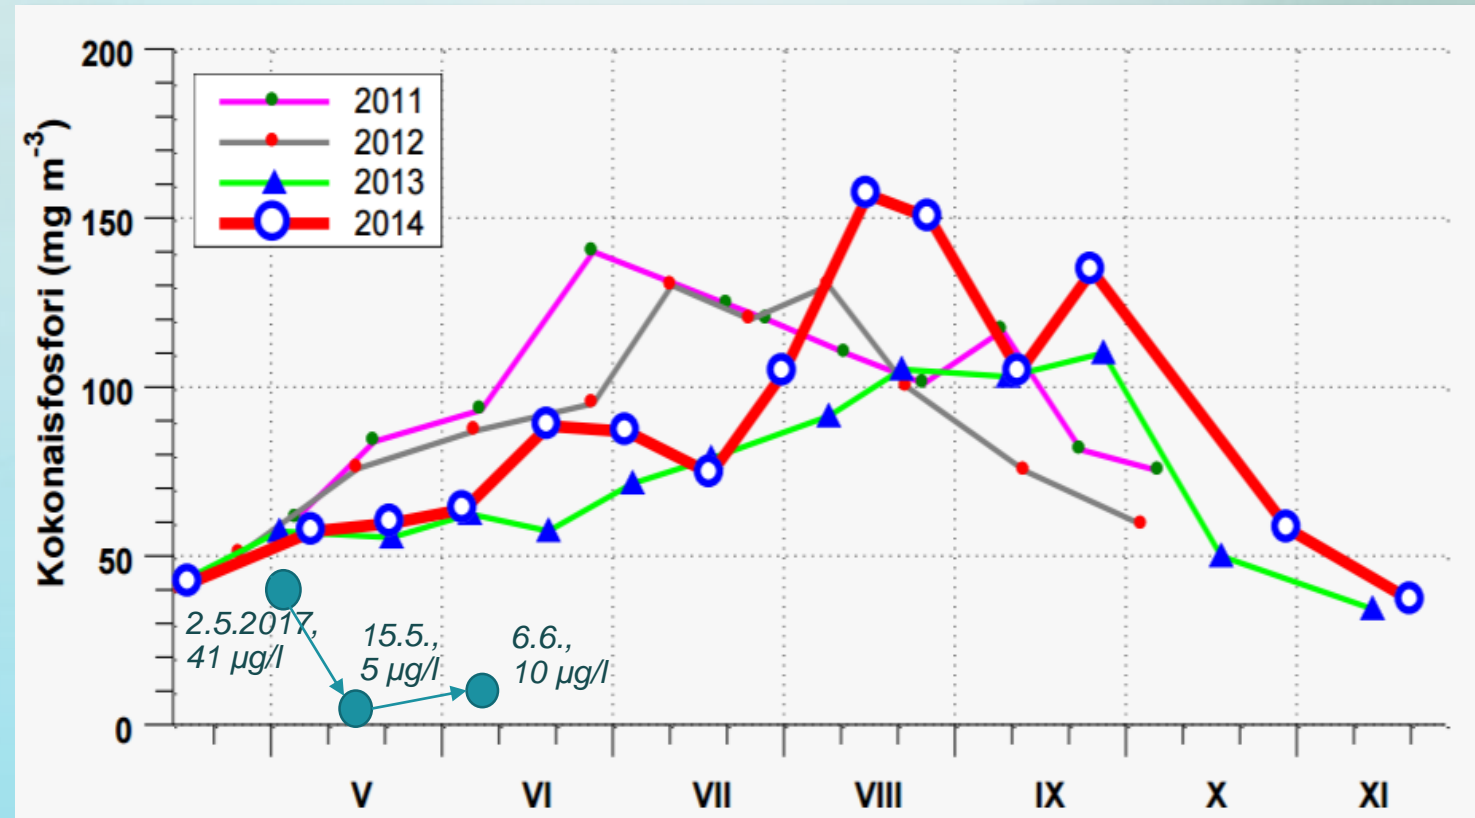
Three days vs. three weeks after: Average of three samples

Phosphorus is gone

- Last ten years: 40... 160 $\mu\text{g/l}$
- 5 $\mu\text{g/l}$ (total 15.5) -> 10 $\mu\text{g/l}$ (total 6.6)...
- < 3 .. 8 $\mu\text{g/l}$ (soluble 5.5 & 6.6.)
- < 3 $\mu\text{g/l}$ (phosphate 6.6)

Aluminium

- Last ten years: 100 $\mu\text{g/l}$
- 630 $\mu\text{g/l}_{15.5}$ -> 45 $\mu\text{g/l}_{6.6}$
 - 3x drinking water guidance value; below the levels of Finnish acidified lakes, now lowest ever measured

Alkalinity very low

- Last ten years: 0,4...0,6 mmol/l
- < 0,04 mmol/l_{15.5} -> 0,13 mmol/l_{6.6}.

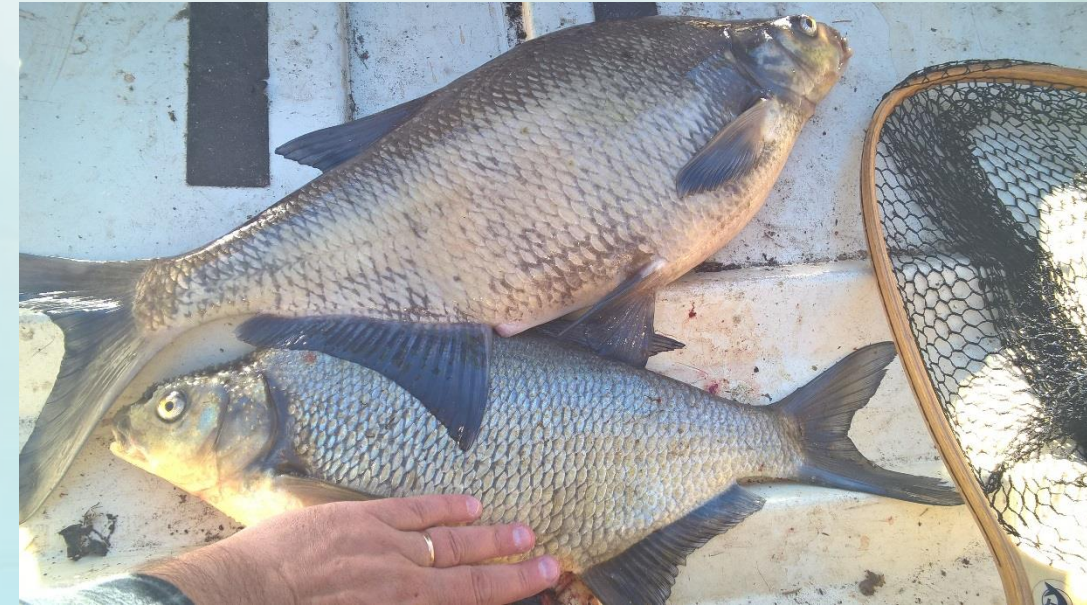
- Fish collected
 - Bream (*Abramis brama*), 97 % of collected fish consists of big breams (8-18 years), 5 tons removed (weighed)
 - Harpoon fishing on Sat 20, 19 participants. Focus on large breams, about 230 dead and 100 alive caught (stats on the right)
 - Pike (*Esox lucius*), a few big ones, 20-30 altogether (max 14kg)
 - Roach (*Rutilus rutilus*), many of all ages
 - Perch (*Perca fluviatilis*), some
 - Eurasian ruffe (*Gymnocephalus cernua*), some
 - Crucian carp (*Carassius carassius*), 10 (max 2kg)
- Insects (casual observations)
 - Mayflies (*ephemeroptera*), reduced hatches (not confirmed)
 - Midges (*nematocera, chironomidae*), hatching
 - Caddisflies (*trichoptera*), hatching
- Mussels
 - Duck mussel (*Anodonta piscinalis*), studied in 24.-25.5.2017. Obviously no significant harm, but the population has shrunk to 1/5th of the 1980's population.

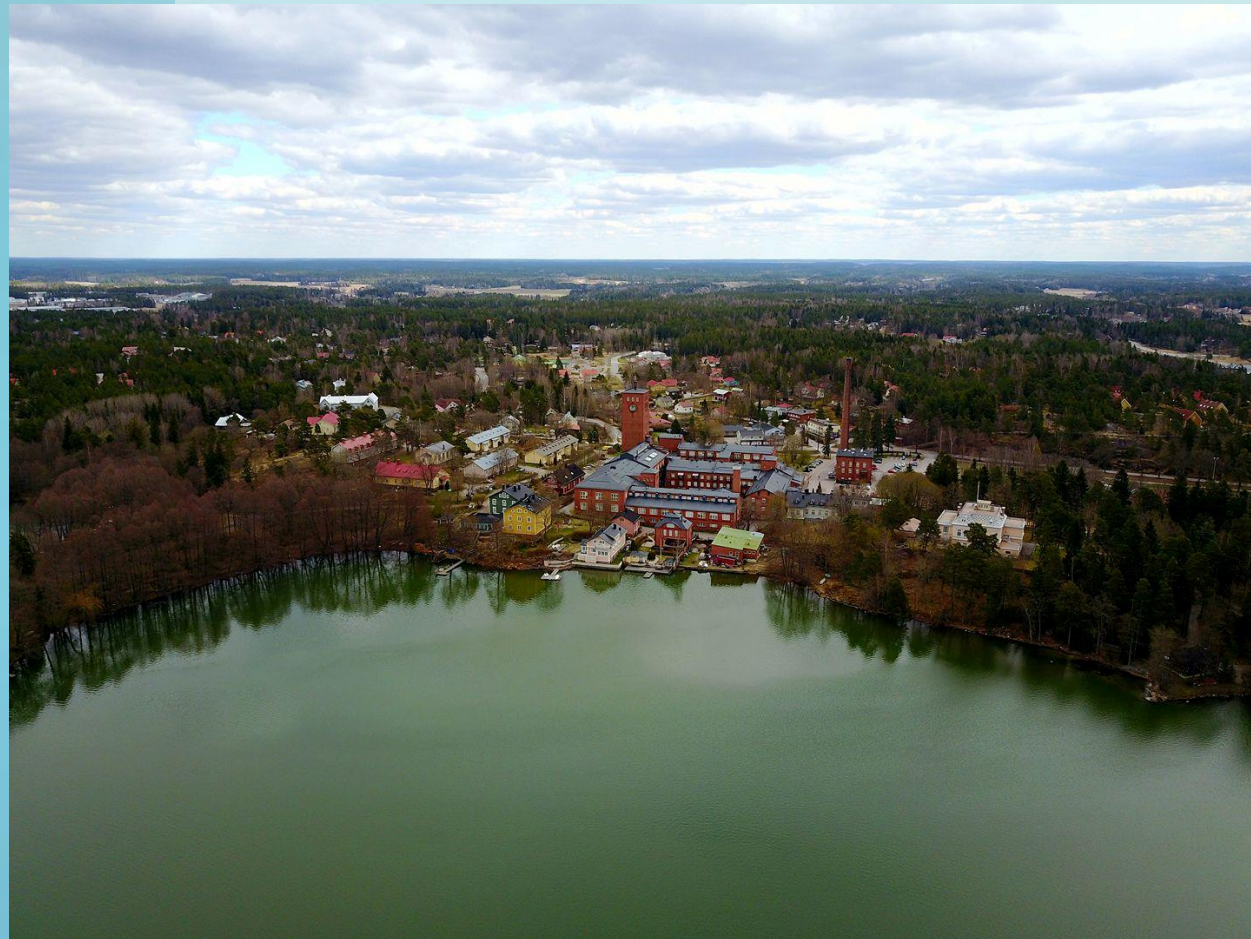
Before, May 2017

- visibility 0,3m
- FNU 4,5...5,1

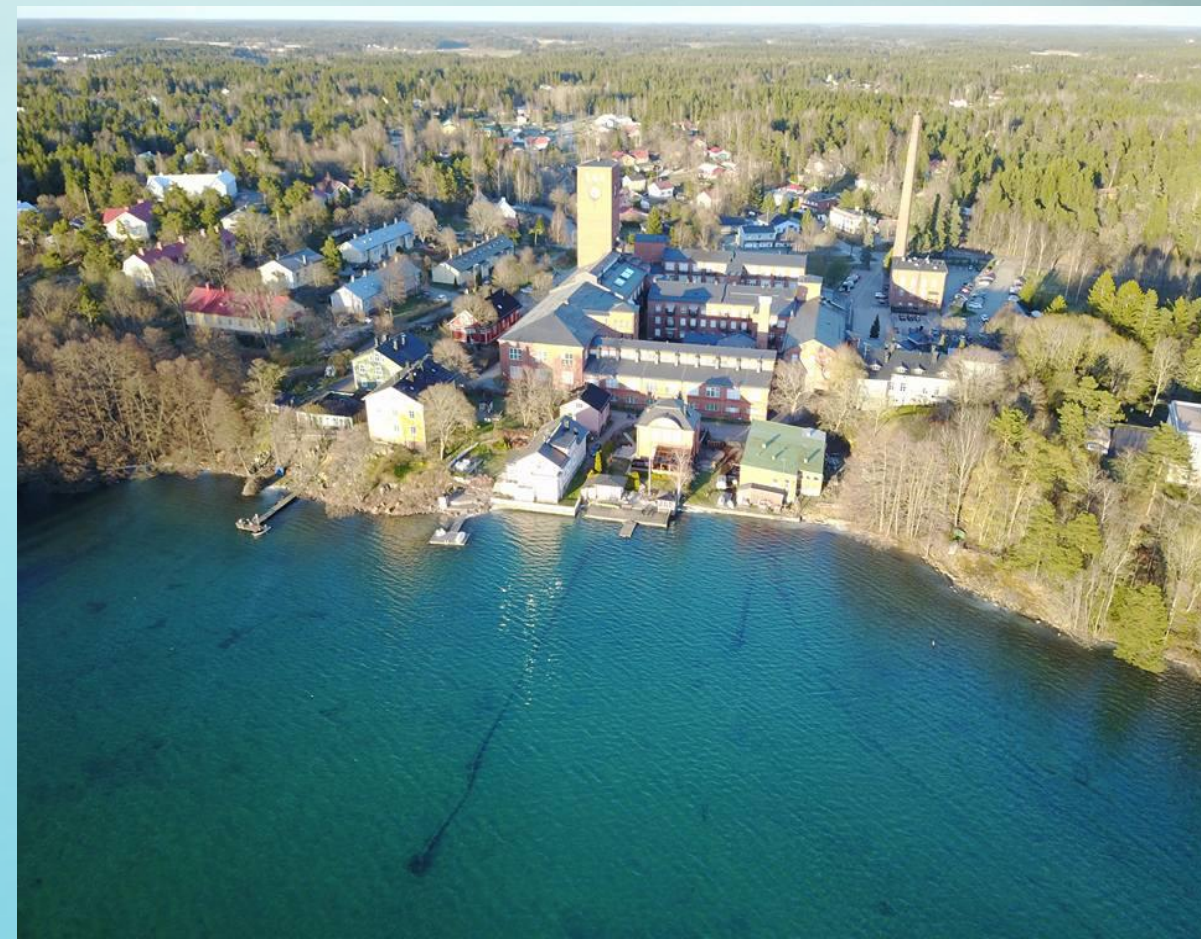
After, May 2017

Early June:

- visibility 1-3m,
- FNU 1,3...2,1
